Manhole Inspection Summary

Manhole # S150__051MH

Insp Date: **4/4/08 1:17 PM**

Location Address: **445 brunswick st**

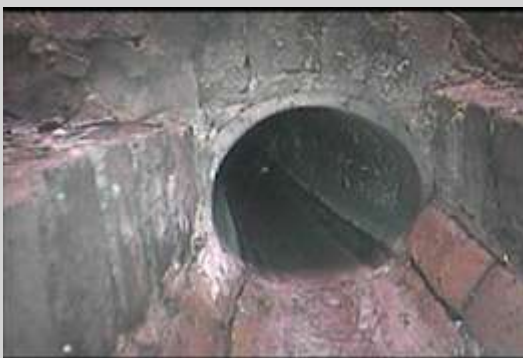
6 O'Clock Inflow

8 in. Circular Gravity Sewer
Pipe In @ 6 O'Clock

Pipe Height: **7.2** (in.) Rod and Bar (Angled)
Pipe Material: **Clay** ☐ Pipe Lined
Invert Depth: **9.02** (ft.) Flow Characteristics: **Slow**
Deposits: ☒ None ☐ Mud ☐ Sludge ☐ Debris ☐ Grease
Silt Depth: **0** (in.) Deposits Extent:
Infiltration: **None** Pipe Seal Cond: **Sound**
